# **MONITORING OF THE SONAPUR LANDSLIDE, JAINTIA HILLS DISTRICT, MEGHALAYA - A CASE HISTORY**

**Maneesh Khar<sup>1</sup> & Pankaj Kumar<sup>2</sup>**

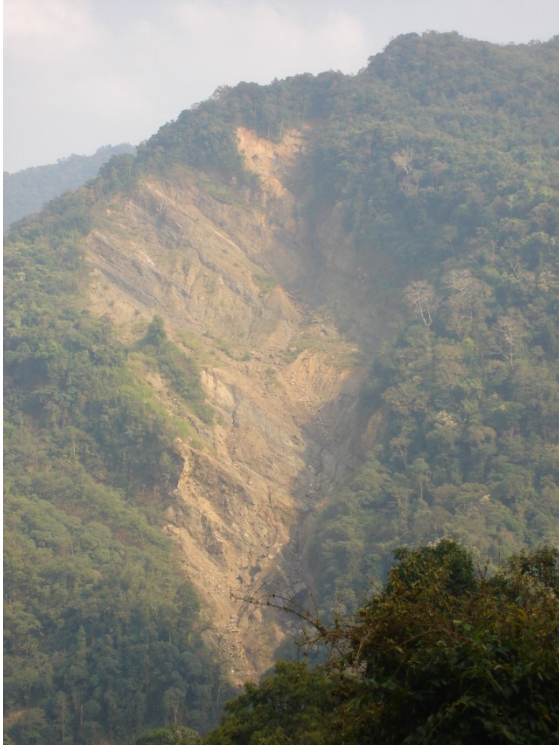
**Photo-1:** View of Sonapur landslide, Jaintia Hills district, Meghalaya

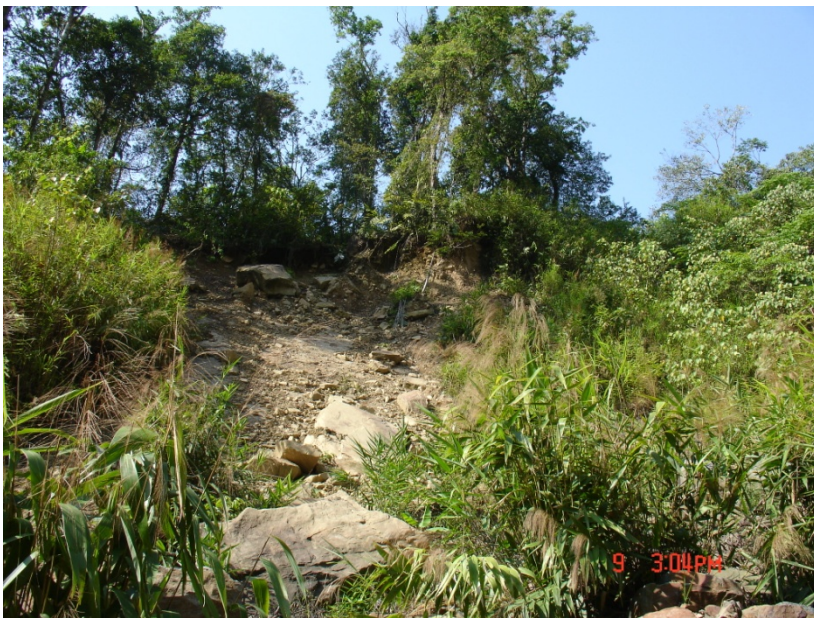
**Photo-2:** Rock sliding along with top soil cover

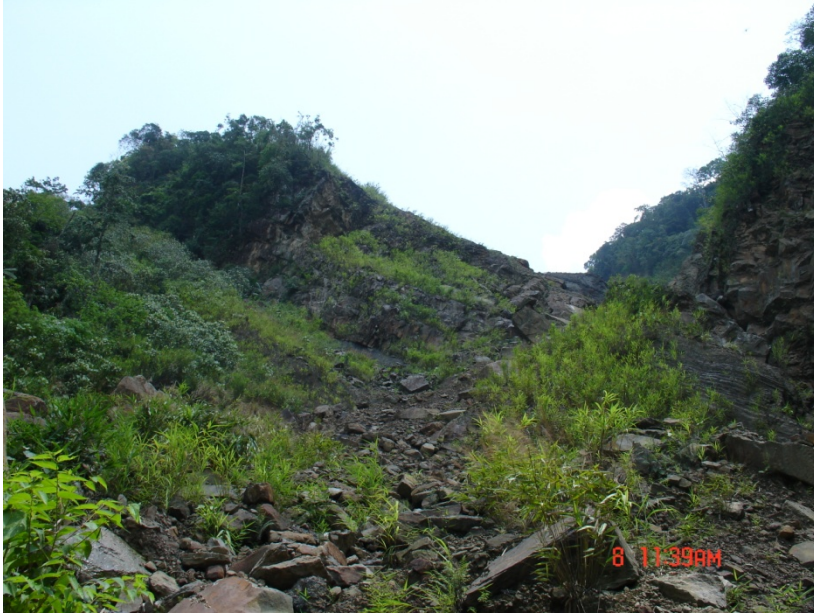
**Photo-3:** Debris accumulated by sliding

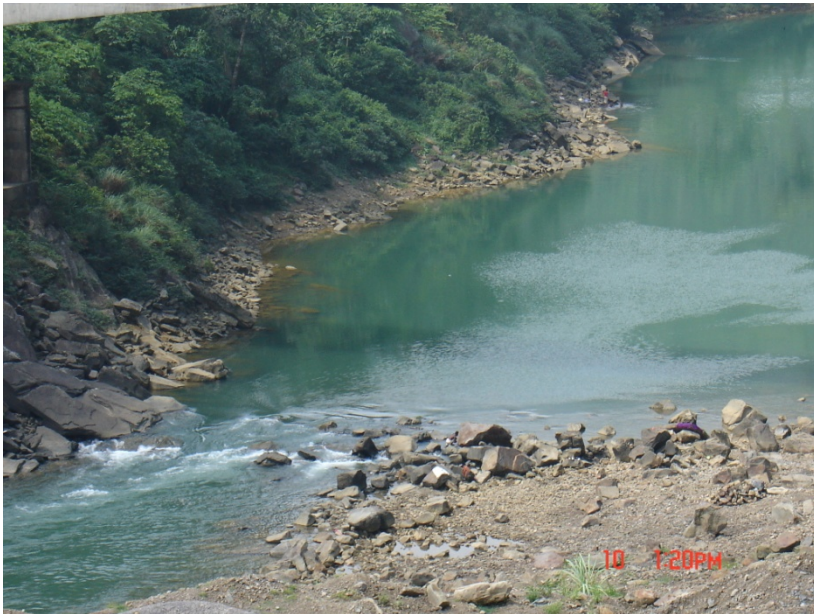
**Photo-4:** Narrowing of Lubha river channel by accumulation of slide debris
