## Engineering Geological Investigation for Sudden Subsidence and Outward Migration of Excavated Slope Accompanied by Muck Flow and Subsurface Seepage at North-east Frontier Railway's Broad Gauge Excavation near Rekho Village, Dima Hasao District, Assam

Dr.Barin Chatterjee\* Consultant Engineering Geologist \*Ex-Director, Geological Survey of India

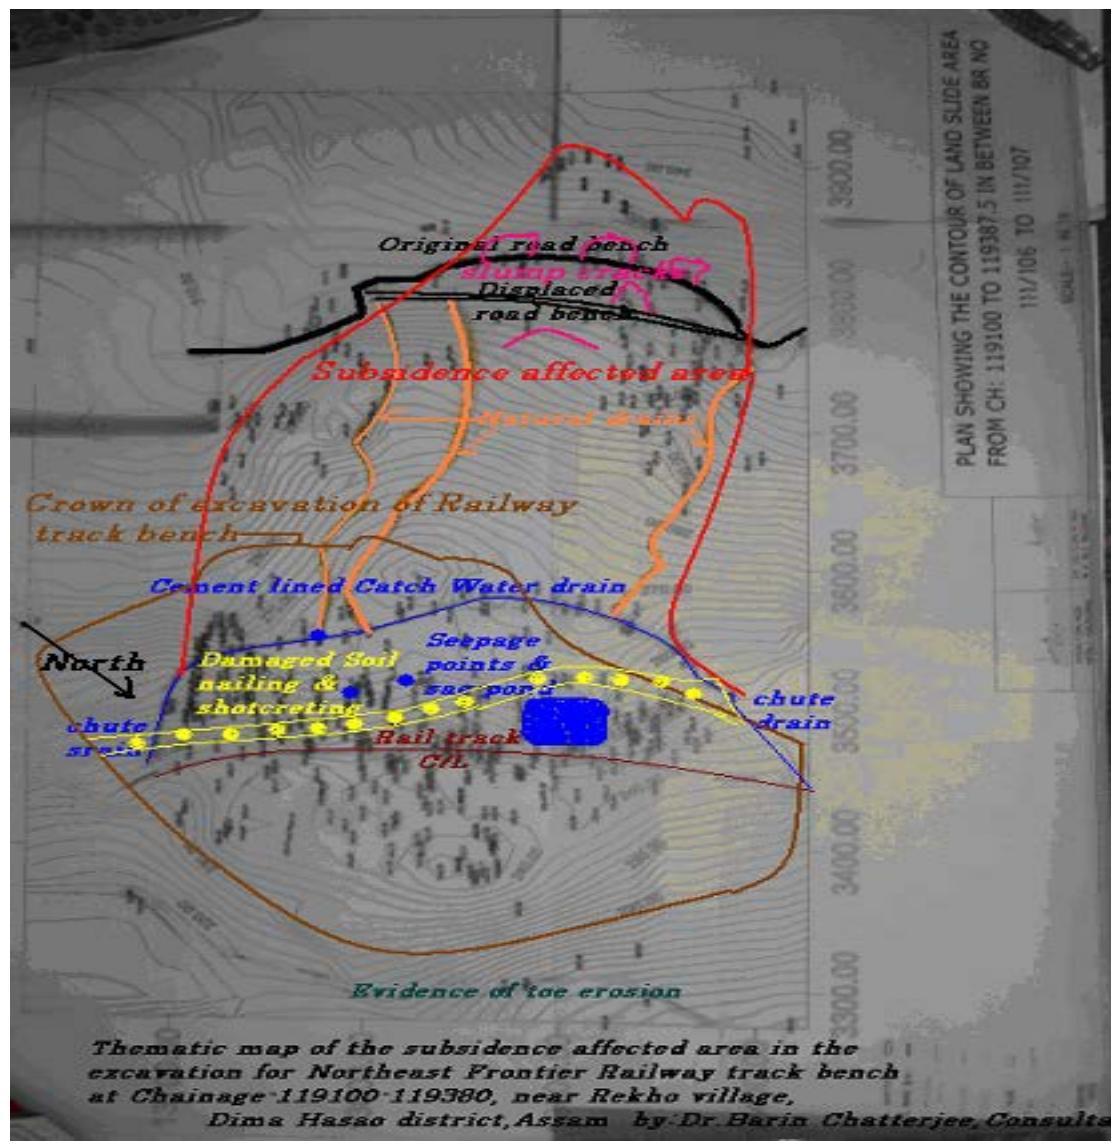
Figure 1

The present observation has been projected as it is in the thematic map (Figure-1) which indicates that this is a two-tier slide/subsidence affected zone. The North-eastward elongated creep-affected zone has been superimposed by the sudden north-ward subsidence affected zone. While the former is the result of seepage water along the contact between the bouldery sandstone underlain by carbonaceous shale, the latter or the most recent abrupt subsidence has been caused by steepening of angle of slope excavation and obstruction to seepage by providing soil nailing and shotcreting. In Figure-2, it has been observed that the steepening of back slope from  $30^{\circ}$  to  $45^{\circ}$  between RD 268.35 m and 262.436 m for reaching the depth below 12 m at the center-line of the finished grade of the bench has resulted the sudden failure of the slope which was collectively

effected by continuous heavy rainfall and development of tremendous pore pressure behind the just shotcreted and soil nailed surface cover.

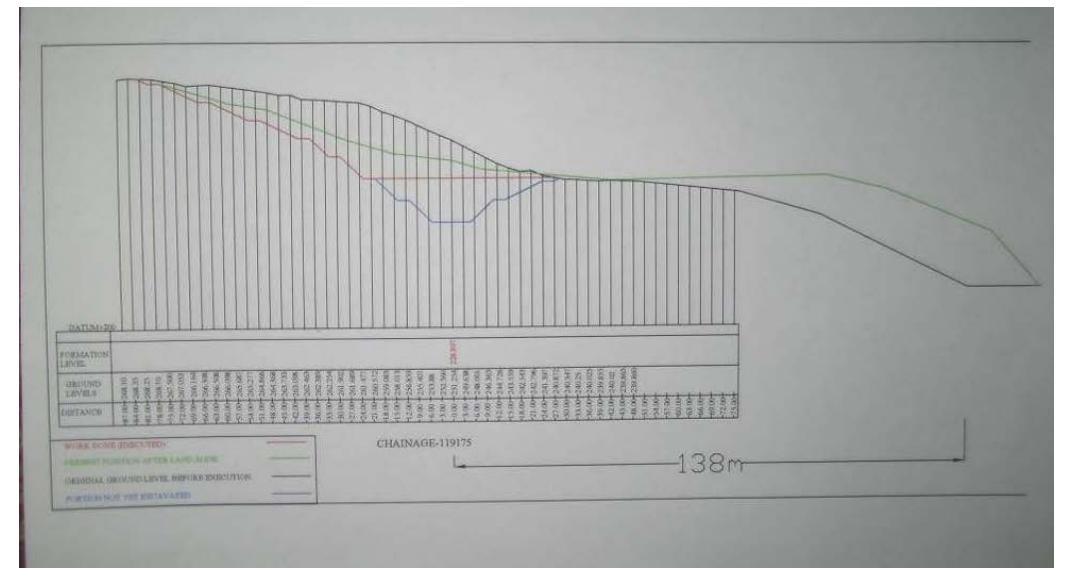
Fig-2

At present, though it is a simple case of seepage and slump affected slope, unless urgent protective measures are taken, it is likely to develop into a deep seated failure of a Rotational or wedge type. Toe-erosion, followed by excavation of bench, changing to steeper slope of cut (Figure-2) in a rainy season, having very high precipitation for three consecutive days causing super saturation in the slope as a whole and concentrated in the middle between the two gullies, particularly under the shotcreted-covered surface. This in turn caused tremendous pore pressure to develop behind the shotcreted surface between the two gullies flowing along the either side. Geological discontinuities like Joints / fractures / bedding/ foliation/ Fault have all contributed to the cause.

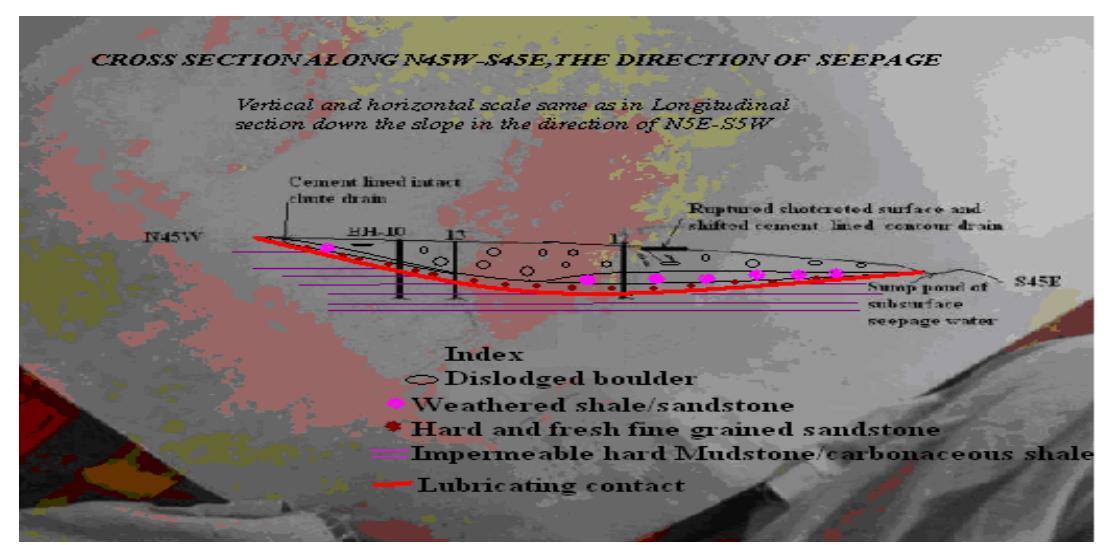
Figure 3: Geological profile of the subsurface in the direction of N45W-S45E

In addition to the removal of the subsurface water, a massive buttress wall has to be erected as a restraining structure at the bottom of the already activated slope near the lines of bore holes 20-26 (Figure-3). For total uplift of the face of the present problem it is suggested to accurately detect subsurface water in rock formations, which is of course now difficult, because the problematic area is covered by dumped material. The subsurface drilling is expected to provide sufficient data, which may necessitate additional measures.

The ultimate objective is to keep the slope-surface as well its subsurface, as dry as possible. While the bottom of the railway track bench, the slope can be loaded to the maximum by sausage walls supported on the proposed buttress wall at the toe region (Figure-3), the upper part of the slope should be left without any additional loading by any construction like sausage wall etc.
