## Design of Remedial Measures at Lukhbir Slide on NH-31A Near Sikkim

P.S.Prasad, Kishor Kumar, Indervir S. Negi & Anil Kathait Scientists, CSIR-Central Road Research Institute, New Delhi

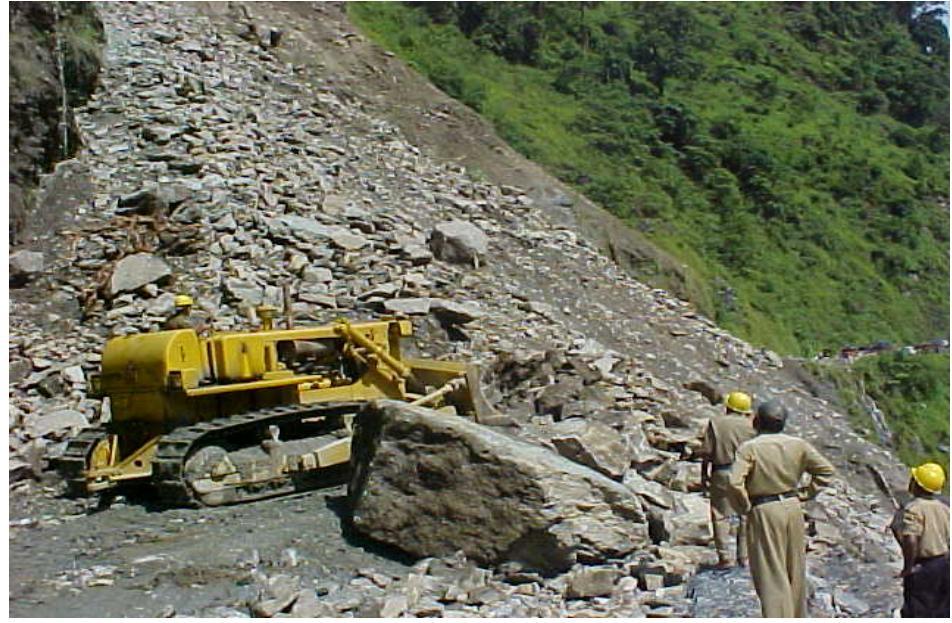
National Highway 31A (NH 31A) links Gangtok to Sevoke and runs along the banks of the River Teesta. Lukhbir slide, active since 1968, is located at km 26.8 on NH 31- A as shown in photograph 1. It covers 400m length of road & approximately 50m active portion & remaining several meters of probable failure area above the road & downhill up to the bank of river Teesta. Several agencies like GSI, CRRI & CWPRS carried out studies on this landslide and suggested a variety of remedial measures like benching of slopes, ceiling of cracks, retaining walls, Brest wall etc. All the time, the remedial measures implemented by BRO, didn't stand up to the violent nature of the slide, particularly during rainy season.

Photo 1. Lukhbiur slide on NH - 31A

The damaged stretch of the road extended to the length of around 400m. The road level (RL) noticed at 230 and the HFL 205. As the Teesta dam project is being constructed actively, it is estimated that the water level will rise up to RL 223, that is in close proximity to the road level involving the landslide affected downhill slope as well. In view of the coming dam & importance of the only highway linking the

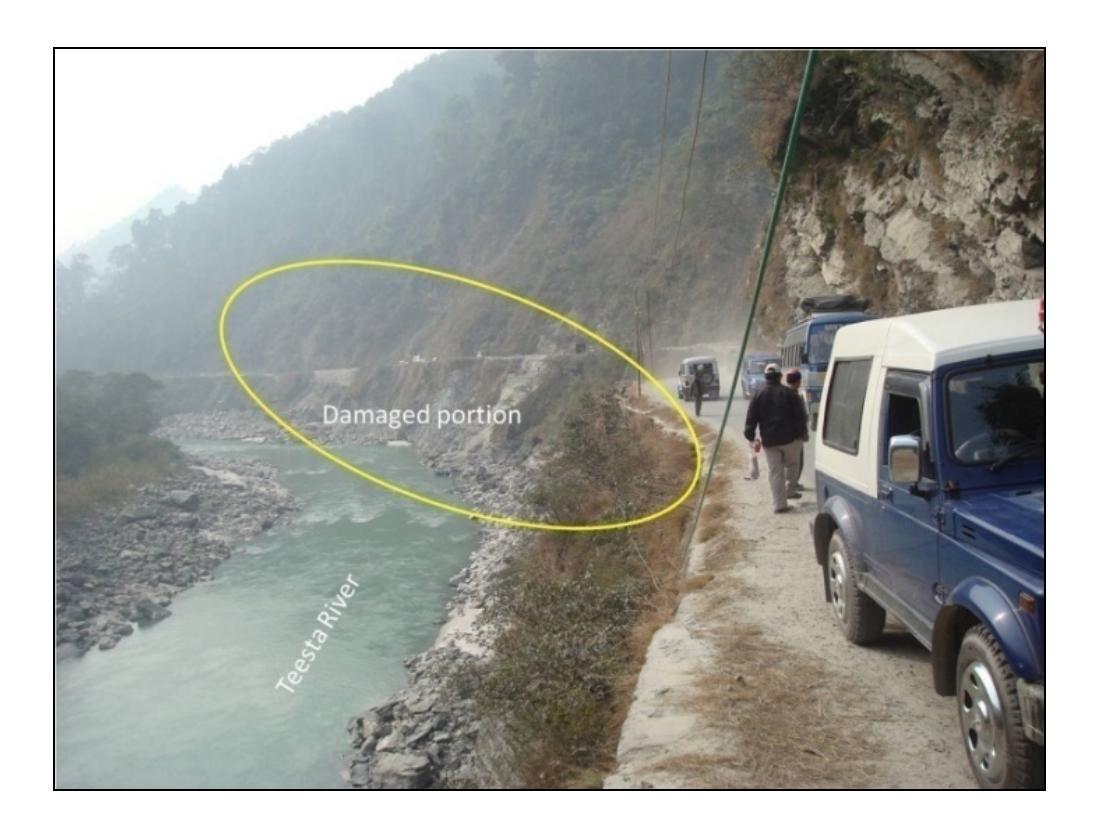
The preliminary investigation included the onsite observations & judgement for probable remedial measures etc. Going through the history of the landslide it was learnt that the initial triggering factor was the intense toe erosion particularly during the high flood instances. Due to this reason repeated damage/subsidence of the highway had been occurring. With frequent damage of highway, to restore the same, instead of strengthening downhill side slope the uphill slope was cut. This practice was repeated almost every time the road was damaged. As a result the uphill slope had become active and continues to be same till date. The focus on preventing the slope uphill side has therefore become a priority and no attention was paid to the need of toe protection. The gradual cutting of the toe may become a cause of concern in years to come. It was therefore required to think holistically to undertake all the measures in view of the long term stability of slope instead of very short term approach.

Photo.2 : Downhill slope damaged due to river meandering

As River Teesta takes a turn (meandering) at the base of the slide resulting in direct impact of the water particularly during the monsoon season (photograph 2), it was proposed to protect the toe from the onslaught of high velocity water. At the same time the uphill & downhill slope from the road was also required to be prevented for long term stability.

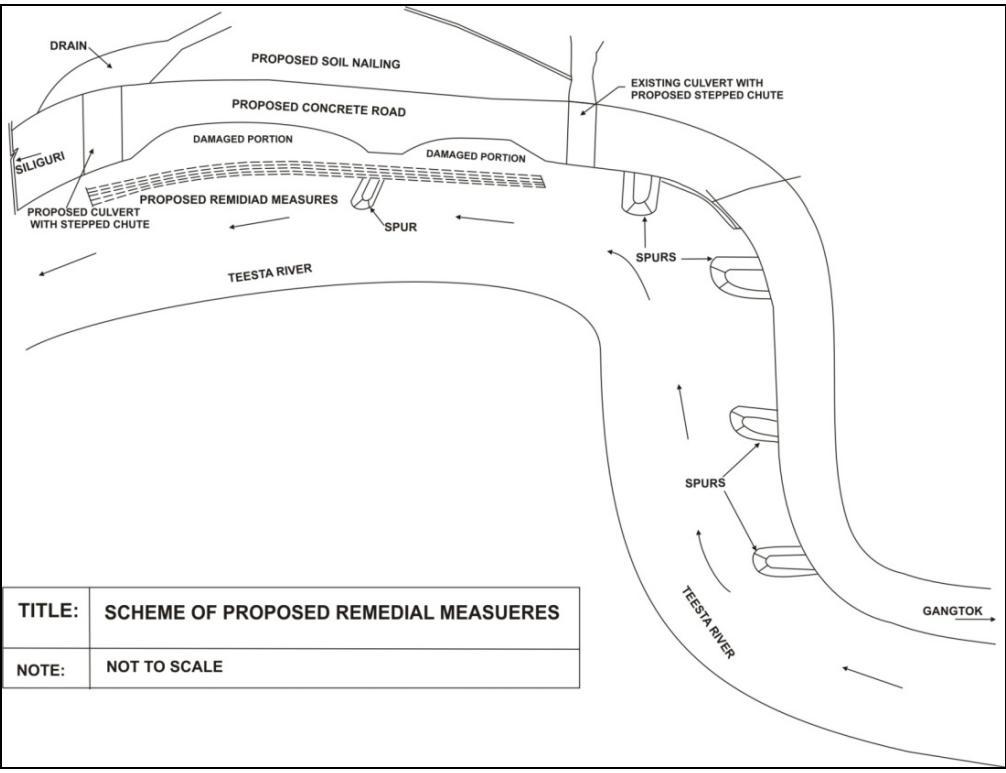
Figure 1. Suggested remedial measures

The design of remedial measures, based on the onsite observation, probable causative factors & stability analyses, was performed as indicated in figure 1. The details however, shall be presented in the final paper. The measures are implemented & the performance may also be discussed in the paper.
