Landslides Management in Rural Roads of Pauri District (Uttarakhand): Challenges & Opportunities

Shakti Prakash¹ & V.V.S. Gulati²

*²Team Leader (Uttarakhand State Roads Improvement Project in Haridwar & Pauri Districts),
URS-Scottwilson India Pvt.Ltd
Email: envshaktiprakash@gmail.com,*

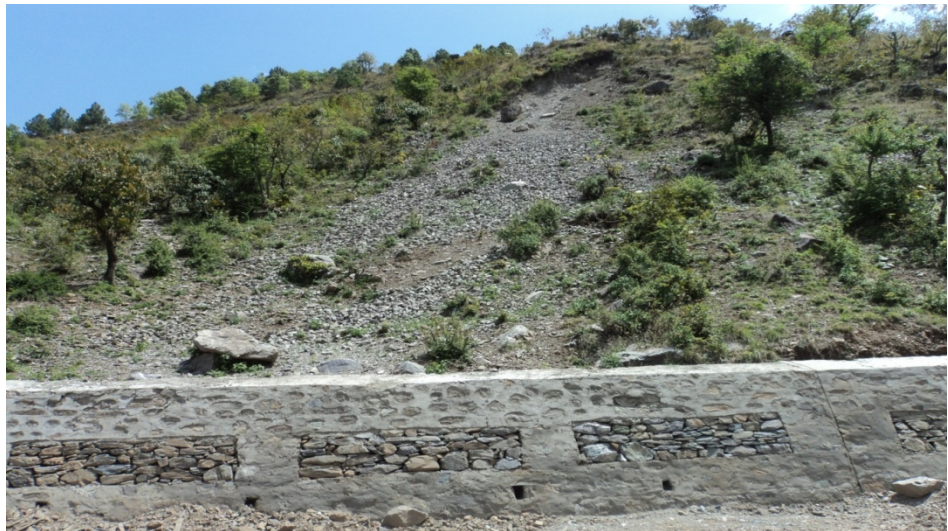
Photograph 1: Mitigation Measure – Breast wall on the road of Contract Package-17

Dimension of above mentioned mitigation measures varies from one slides to another depending upon the aerial extent, causes, severity. Similar is the case with cost of implementing suggested mitigation measure. Photographs 1 & 2 provide glimpses of two mitigation measures implemented widely in Contract Package-17 in rural roads of Pauri district. More photographic details about road & location specific measures will be provided in the detailed paper

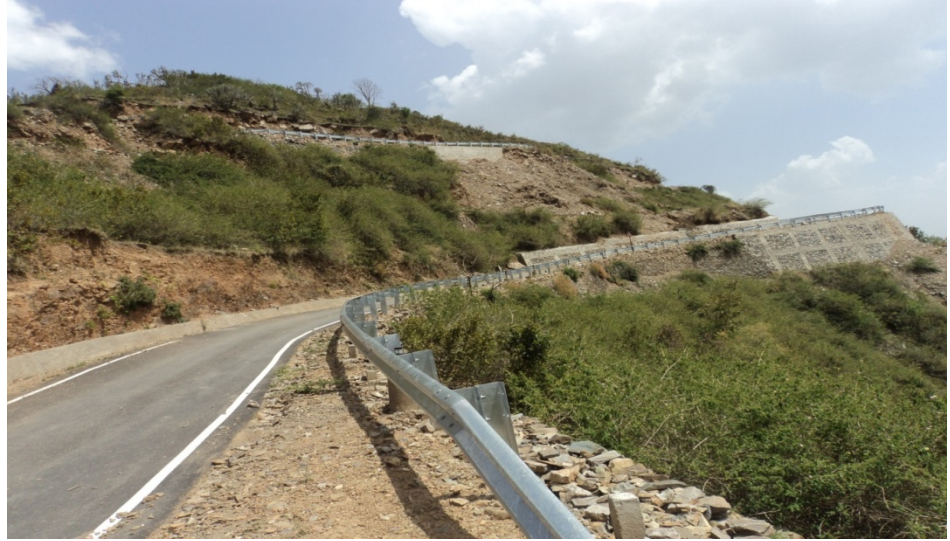
Photograph 2 : Mitigation Measure – Gabion with Wirecrete on the road of Contract Package-17
