## Engineering Geological Investigation for Sudden Subsidence and Outward Migration of Excavated Slope Accompanied by Muck Flow and Subsurface Seepage at North-east Frontier Railway's Broad Gauge Excavation near Rekho Village, Dima Hasao District, Assam

Dr.Barin Chatterjee\* Consultant Engineering Geologist \*Ex-Director, Geological Survey of India

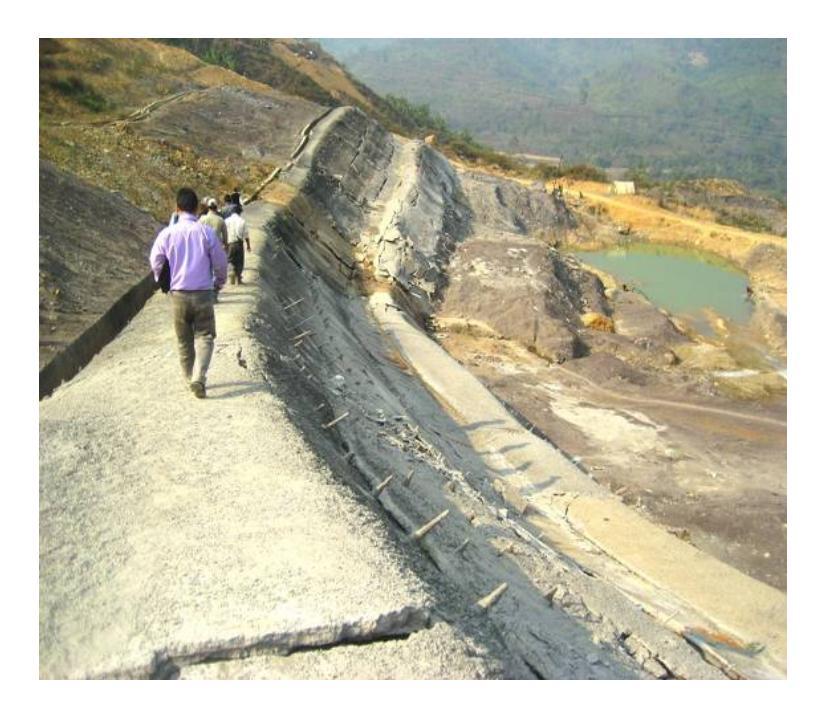
Figure 1

The present observation has been projected as it is in the thematic map (Figure-1) which indicates that this is a two-tier slide/subsidence affected zone. The North-eastward elongated creep-affected zone has been superimposed by the sudden north-ward subsidence affected zone. While the former is the result of seepage water along the contact between the bouldery sandstone underlain by carbonaceous shale, the latter or the most recent abrupt subsidence has been caused by steepening of angle of slope excavation and obstruction to seepage by providing soil nailing and shotcreting. In Figure-2, it has been observed that the steepening of back slope from  $30^{\circ}$  to  $45^{\circ}$  between RD 268.35 m and 262.436 m for reaching the depth below 12 m at the center-line of the finished grade of the bench has resulted the sudden failure of the slope which was collectively

effected by continuous heavy rainfall and development of tremendous pore pressure behind the just shotcreted and soil nailed surface cover.
