# **MONITORING OF THE SONAPUR LANDSLIDE, JAINTIA HILLS DISTRICT, MEGHALAYA - A CASE HISTORY**

**Maneesh Khar<sup>1</sup> & Pankaj Kumar<sup>2</sup>**

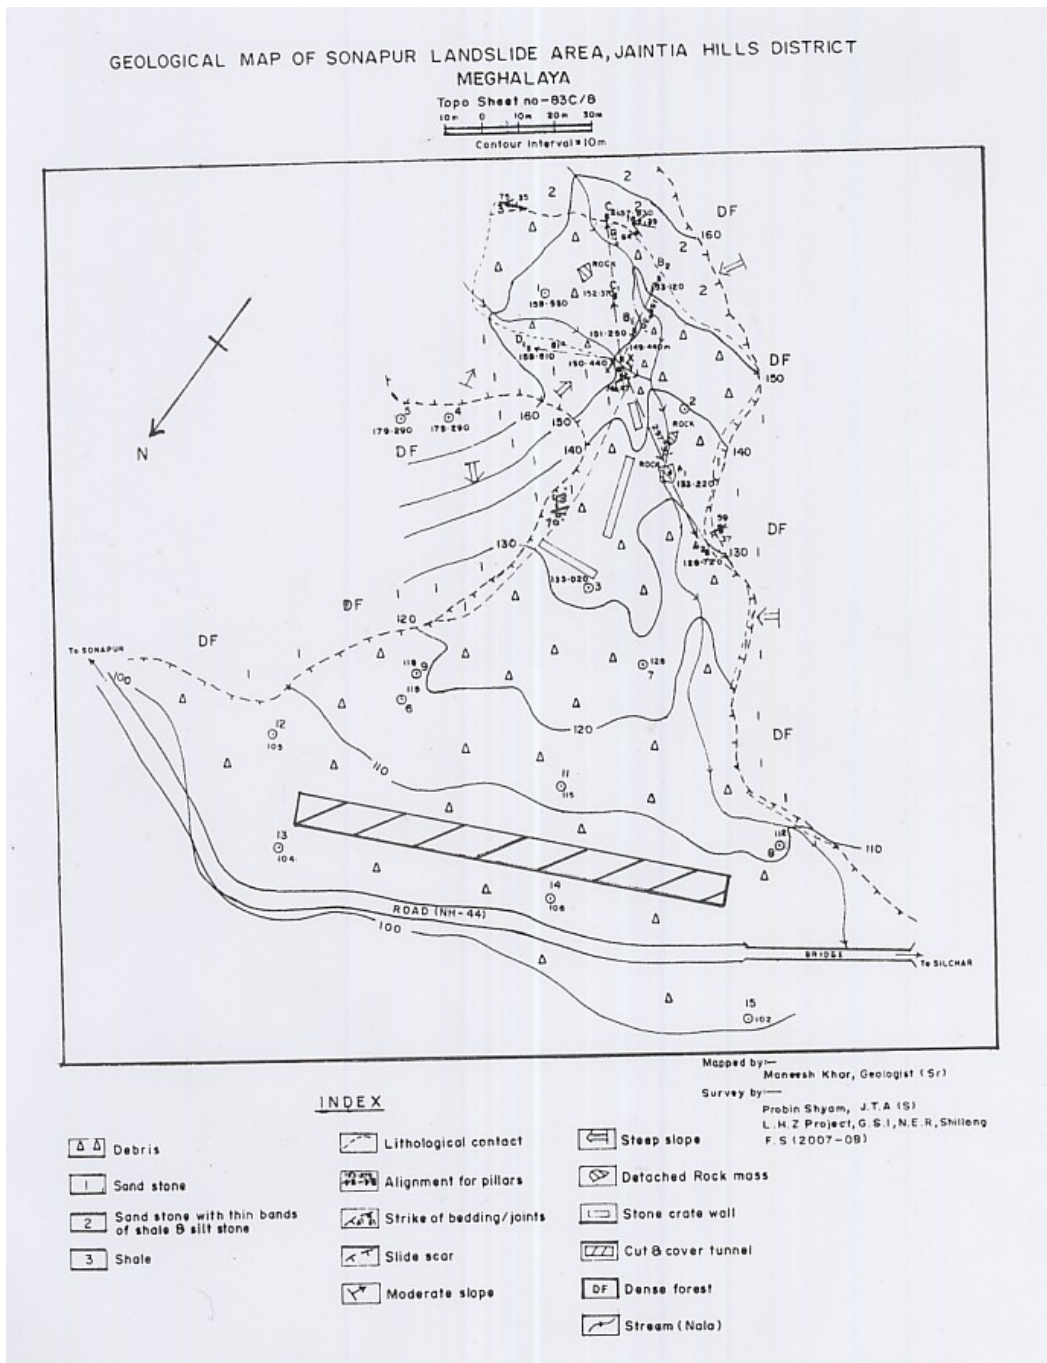
**Fig.1 Geological map of Sonapur landslide**

The monitoring of the slide zone was taken up between May, 2008 and September, 2008. The zone of accumulation and toe part of the slide was mapped on 1:1,000 scale. Permanent reference pillar X was installed on the insitu sandstone (Fig.-1). The main reference pillars and permanent reference pillar were erected in the slide zone and monitoring was carried out using digital theodolite at regular intervals. These pillars were installed by constructing concrete and brick pillars. Assuming X as the permanent reference Station, seven reference pillars were installed in four alignments. The X-A1-A2 alignment direction is  $297^{\circ} \pm 30'$  where A1 reference pillar was installed on a detached sandstone block (4m X 5m X 2m) in the debris and A2 reference pillar was installed on a detached sandstone block (3m X 2m X 2m) towards the southern flank of the slide. The X-B1-B2 alignment direction is  $166^{\circ} \pm 30'$ , the B1 reference pillar was erected on sandstone boulder (2m X 1.5m X 1m) forming part of the debris. The B2 reference pillar was placed at left flank of the slide on debris material consisting chiefly shale, clay and sand stone fragments. The X-C1-C2 alignment direction is  $137^{\circ}$ . The C1 reference pillar was placed on debris. The C2 reference pillar was erected on the insitu rock- sand stone on the left flank of the slide. The X-D1 alignment is  $61^{\circ}$  where D1 reference pillar is placed on insitu sandstone unit. In addition ( X  $\pm 30'$  ) RL 150.44m observation point were marked on insitu sand stone 1m above the reference station X. The A  $\pm 2'$ , B  $\pm 2'$ , C  $\pm 2'$  and D  $\pm 1'$  observation points also were marked on insitu rocks by the side of A2, B2, C2 and D2 reference pillars for reference purpose in case of washing out of reference pillars during heavy rains. Monitoring work was taken up periodically with help of digital theodolite to notice any movement in the slide zone. Till August, no displacement in the position of reference pillars was observed. However, in September, it was observed that four reference pillars (nos. A1, A2, B1 & C2) had been washed out along with debris movement in the slide zone. These four erected reference pillars were dislodged from their respective places and no trace of these pillars were found. Erected permanent reference pillar no.- X was also washed out but the in-situ rock on which the X was placed was intact. Reading of other three observation pillars no.- B2, C1 & D1 were taken and no significant movement was found.
